# THE FIJI COMMONWEALTH TRAINING CHAMPION'S TRAINING IN ENGLAND

## *Canterbury Cathedral*

## *Hurst Castle*

## *Winchester Cathedral*

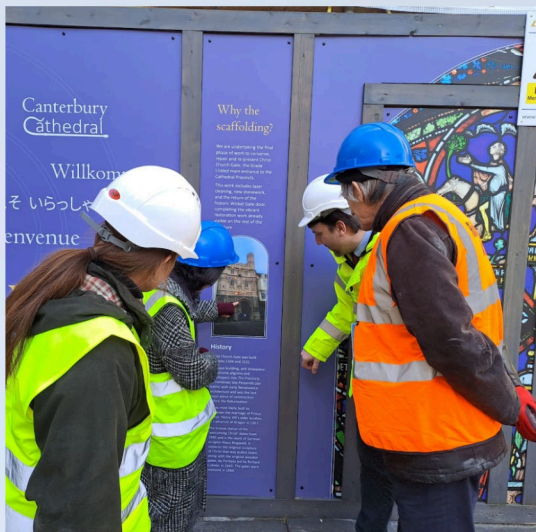
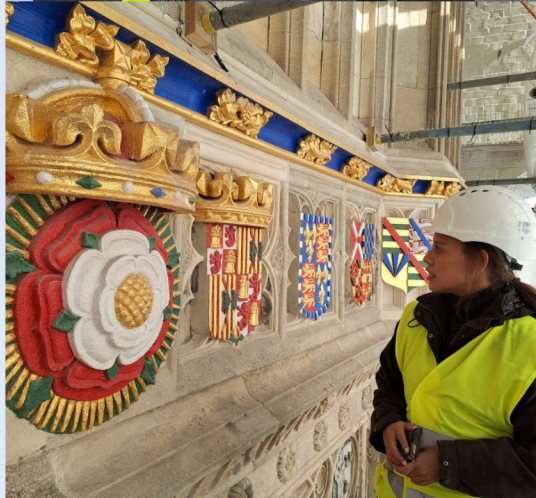
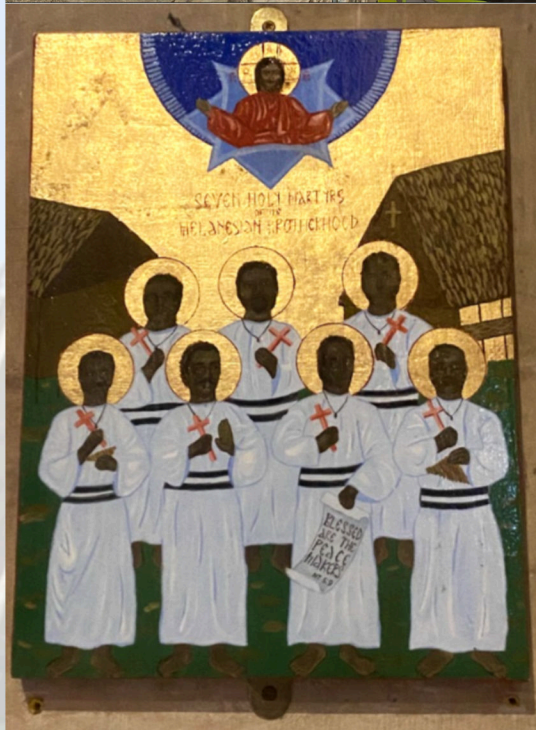
## *Maintenance and Restoration*

Purcell Architects played a key role in the conservation of the Christ Church Gate, a Grade I-listed main entrance to the Cathedral Precincts which was built between 1501 and 1521. The Christ Church Gate combines late Gothic with early Renaissance architecture and was the last major piece of construction before the Reformation.

In the 1950's the Gate began to significantly deteriorate,, restoration work, which began in 2018, involved structural repairs and the revival of the Christ Church Gate's intricate carvings, gilded stonework and reinstating the polychromy - the restoration of the vivid multicoloured architectural details, elements, sculptures and surfaces.

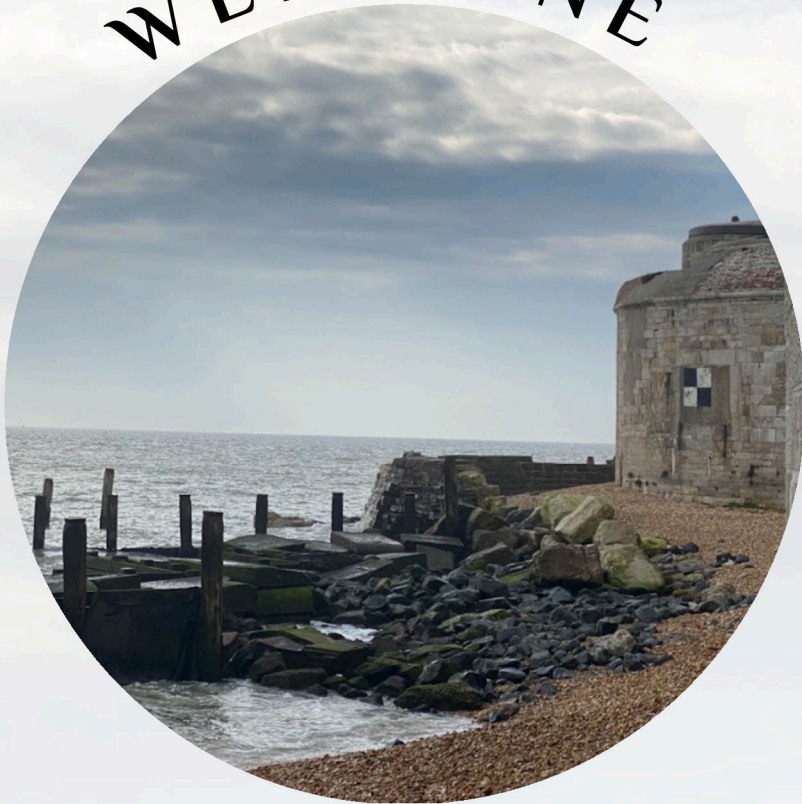
**Zigzag wooden groynes and 10-tonne granite boulders form Hurst Castle's first-line coastal defense system, exemplifying the various disciplines involved in heritage conservation. The groynes' strategic pattern slows powerful longshore drift, trapping vital sediment to maintain the shingle beach. Meanwhile, the massive boulders remain in place to absorb and disperse wave energy that would otherwise undermine the castle's historic foundations and façade.**

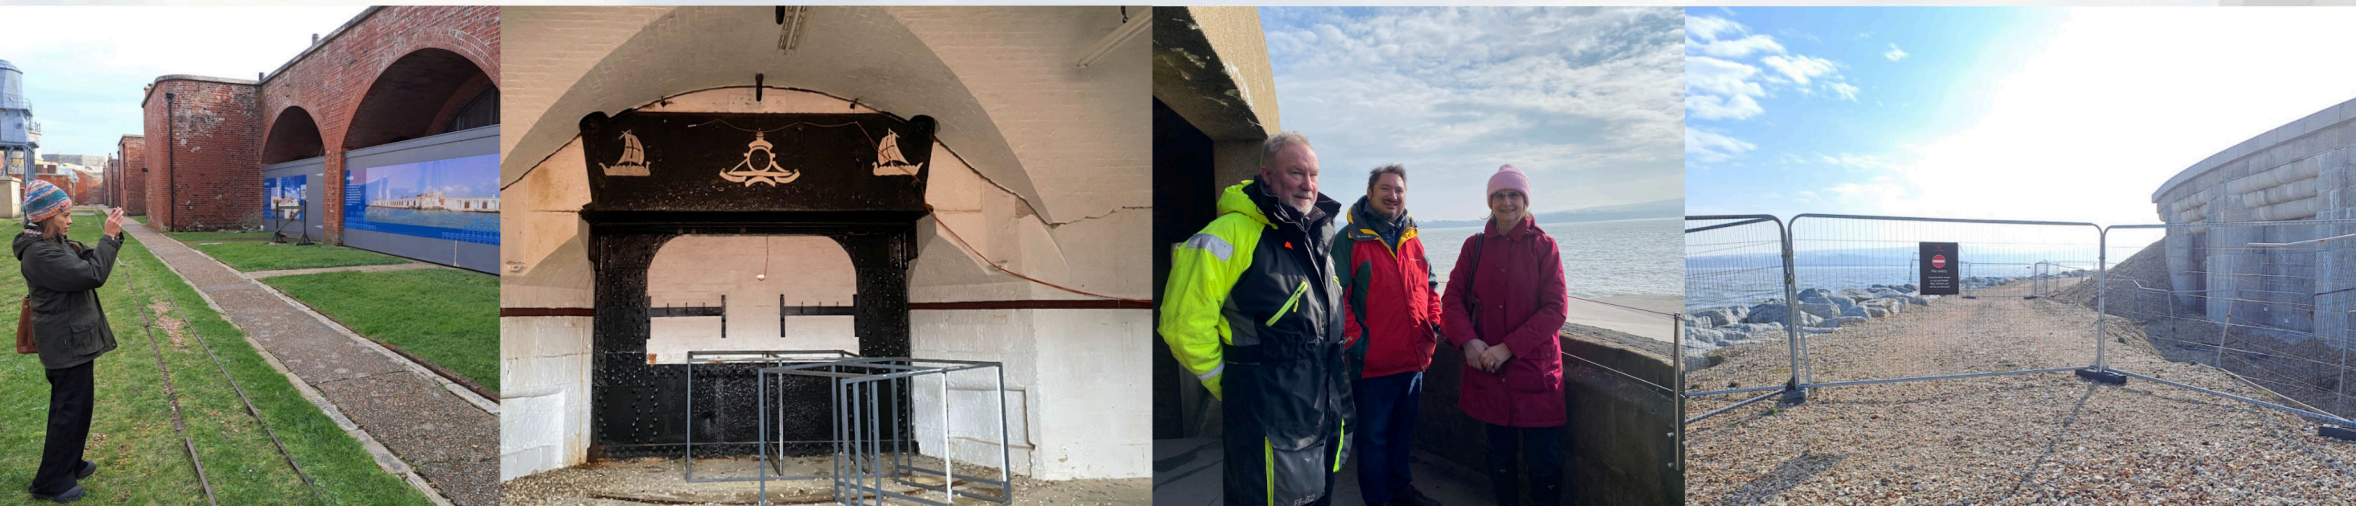
## *Structural Safeguards*

After Hurst Castle's East Battery collapsed in 2021, English Heritage installed monitoring systems including GPR, laser scanning, and 3D LiDAR to track structural issues in masonry, ceilings and archways. Steel props and grout stabilized foundations, while sensors monitor coastal defenses and environmental conditions in storage areas. These measures address immediate vulnerabilities and long-term climate threats to the historic coastal site. Information panels shield archways to prevent visitor injuries from falling debris during future potential collapses.

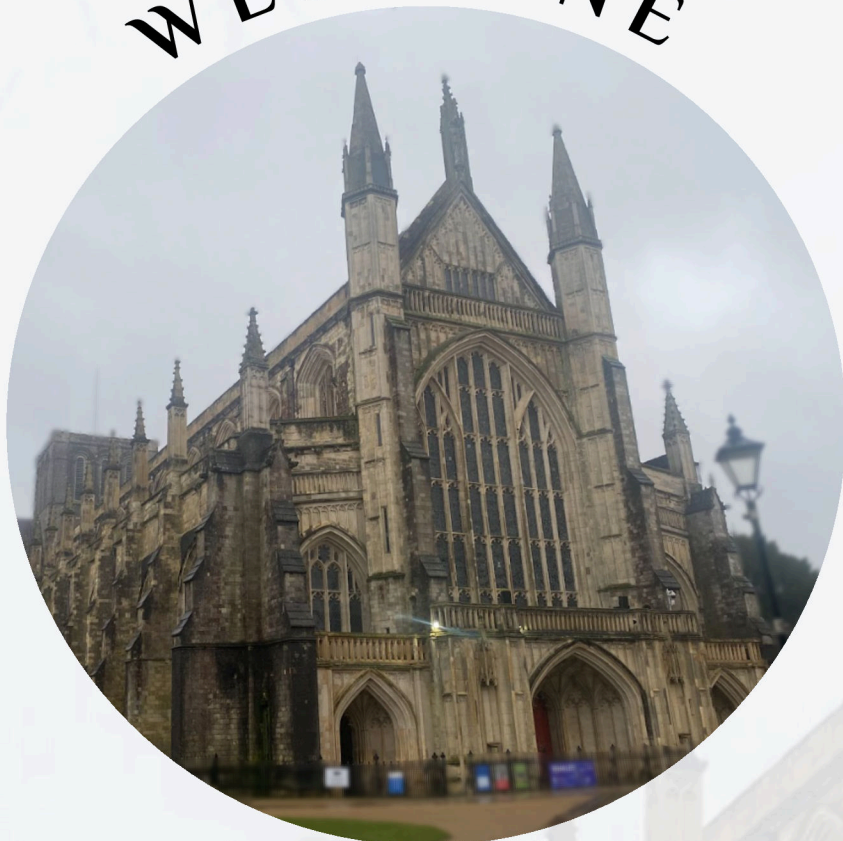
**Between 1906 and 1911, Winchester Cathedral underwent critical underpinning to address structural instability caused by its foundation on soft peat. Engineers and architects implemented a multi-step intervention. Trenches were dug around the walls, and Diver William Walker worked underwater to place concrete bags and blocks under the foundation, while concrete injection strengthened the base. Continuous monitoring ensured the cathedral's stability was restored.**

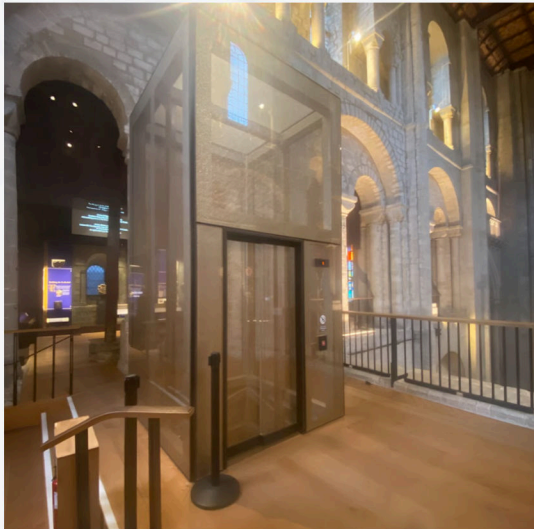
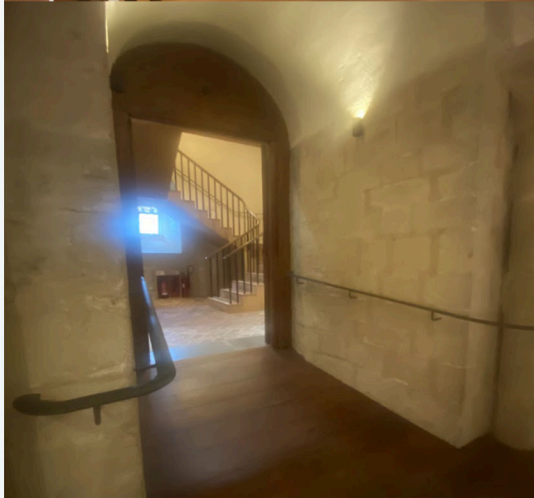
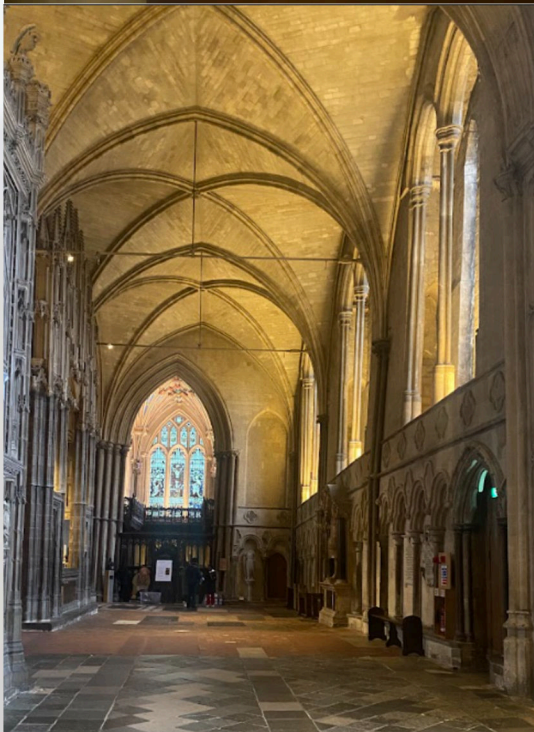
## *Sympathetic Accessible Interiors*

Winchester Cathedral has implemented a light-illuminated Stannah passenger lift and rampways, to enhance universal accessibility while preserving its historic architecture. The lift, part of a £11.5 million project, seamlessly integrates into the medieval structure, featuring glass cladding with bronze mesh and landing doors that maintain natural light and aesthetic harmony with the cathedral's golden tone ambience. Rampways provide step-free access to exhibition spaces and learning facilities, ensuring inclusivity for all visitors. These seamless interior interventions align with universal design principles, balancing modern accessibility with the cathedral's heritage.

## *Structural Safeguards*

Winchester Cathedral's vaulted ceilings incorporate steel structural braces to ensure stability. The steel braces are carefully integrated to support the ribbed vaults, distributing weight evenly and preventing structural stress. For the columns, which are not perfectly upright due to centuries of settlement, engineers employed non-invasive monitoring and reinforcement techniques. These include precision steel ties and braces to counteract lateral forces while preserving the original stonework.
